Saab 900 Convertible Top Replacement

as performed March 2007 on a 1991 900 turbo by M.D.O., Hillsborough NC

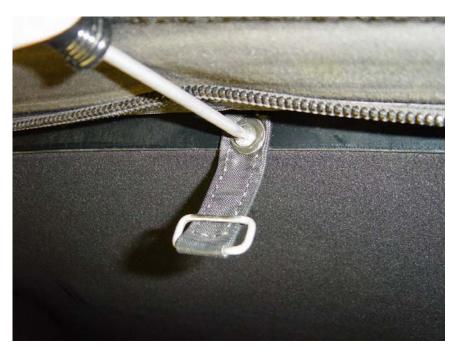
Figure 7: Removing fasteners connecting headliner to rear bow (not required unless replacing headliner)

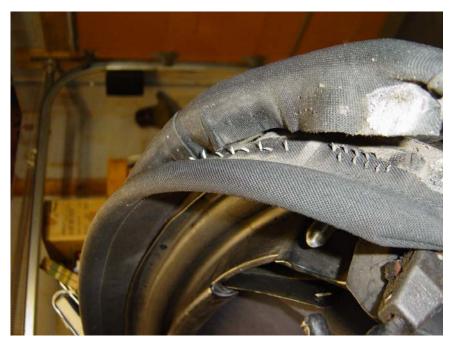
Figure 8: Removing wind stop and main top from front bow

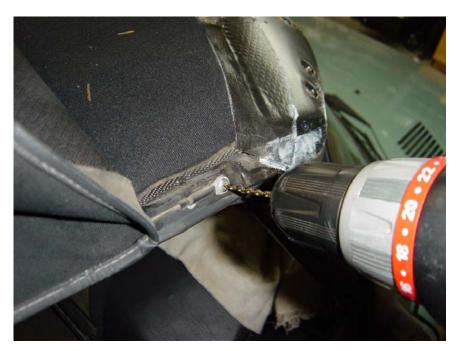
Figure 9: Drilling out pop rivets that hold the side cables at the front corners of the top. I started with 1/8" and finished with 9/64, then used a dental like tool to clean out the old rivet parts from back side of the hole. There is some black caulking that gets messy here – use adhesive remover to clean your hands and tools.

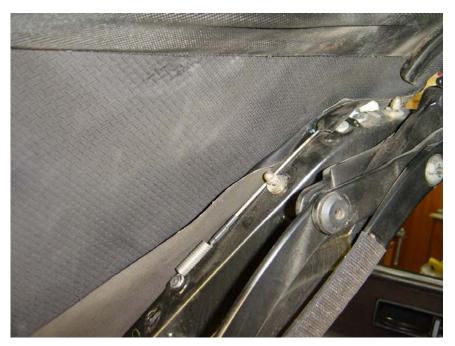
Figure 10: Removing weather strips from above the rear quarter windows. The holes above and below the coil spring are where torx screws were; I have not yet removed the two cap nuts toward the upper right of this photo.

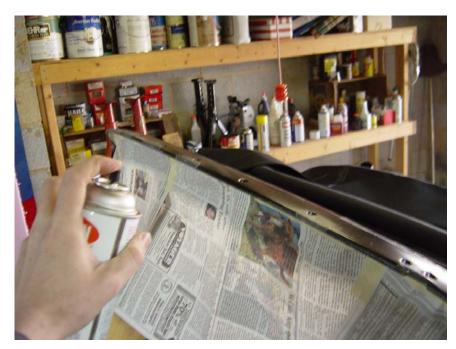
Figure 23: Painting to mitigate corrosion of aluminum front bow.

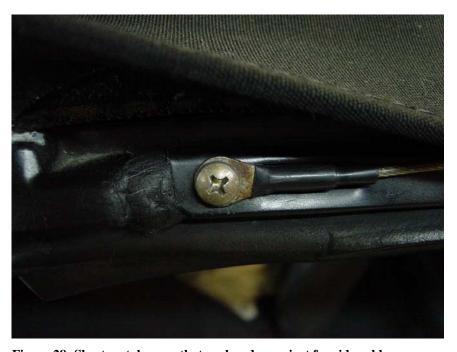
Figure 28: Sheet metal screw that replaced pop rivet for side cable.

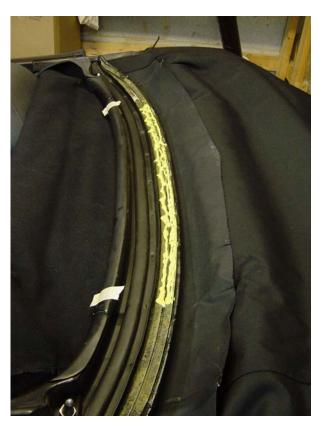
Figure 30: I glued the middle first (between the two spots of making tape), let that dry, then checked the fit before I glued the outsides. Use lots of glue on the front bow because the staples do not hold well.

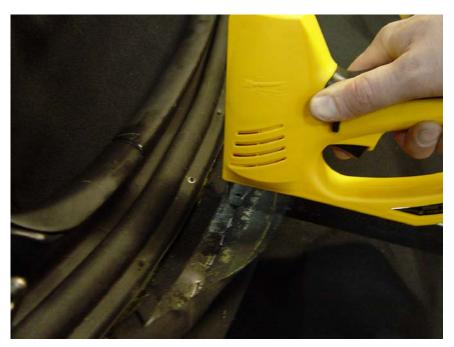
Figure 35: Stapling wind stop under front bow (staples go under the flap). These staples do not hold well so use adequate glue.

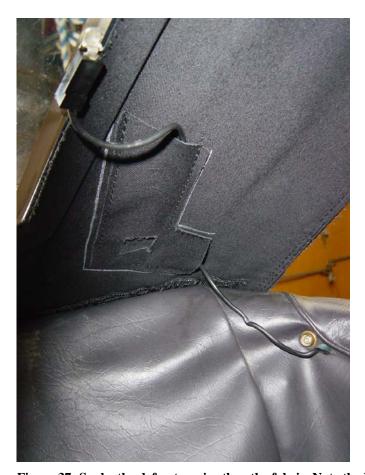
Figure 37: Snake the defroster wire thru the fabric. Note the Velcro for the headliner is partially hidden under the stapled area. This is another indicator I had the rear window section too low, but at this point I had already trimmed the excess fabric so I added self adhesive Velcro above the original Velcro.

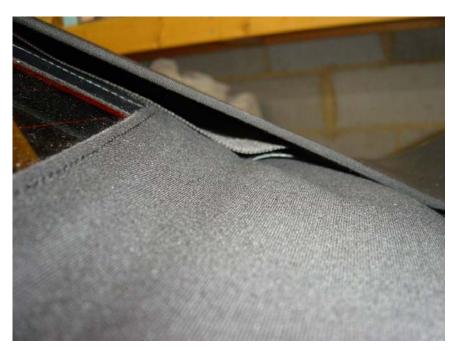
Figure 41: Here is a problem -- the tension of the new top when closed caused the rear window and the support strap above it to be loose. You can't know whether this will happen to you, just anticipate the top fitting will take extra time. I disassembled the rear section to retension the rear window and support strap.

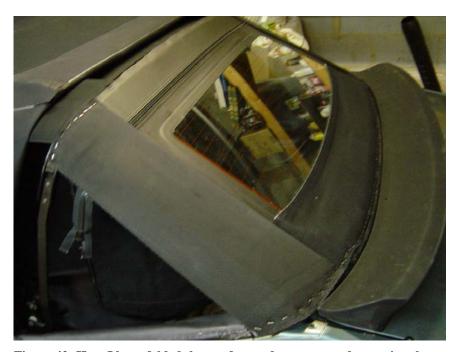
Figure 42: Here I have folded the top forward to access and retension the rear top assembly.

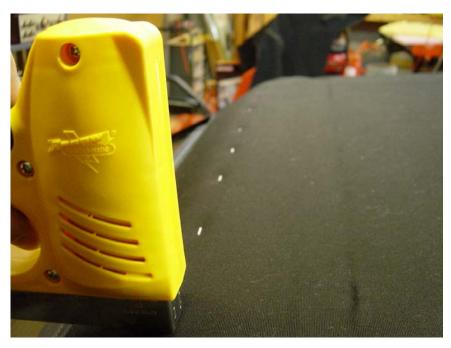
Figure 46: Stapling top to rear bow. It is critical the staples be in a straight line here so they will be hidden under the trim.

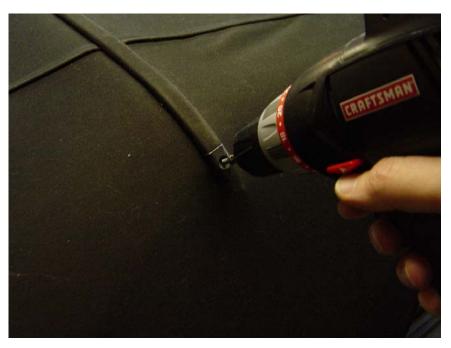
Figure 47: Last step of trim installation. I wanted to reuse the screw holes in the bow from the prior installation, but found that too difficult to locate. Installing the screws in new locations seemed to work pretty well.

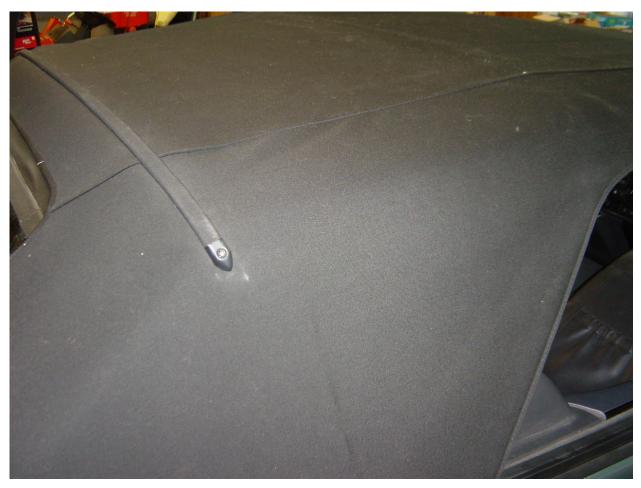
Figure 49: Done! At the time of writing I have driven the car for a month and no problems.
